[Docket No. FAA-2006-24446; Directorate Identifier 2005-SW-15-AD; Amendment 39-14561; AD 2006-08-06]

Airworthiness Directives; Eurocopter France Model SA-360C, SA-365C, SA-365C1, and SA-365C2 Helicopters

ACTION: Final rule; request for comments.

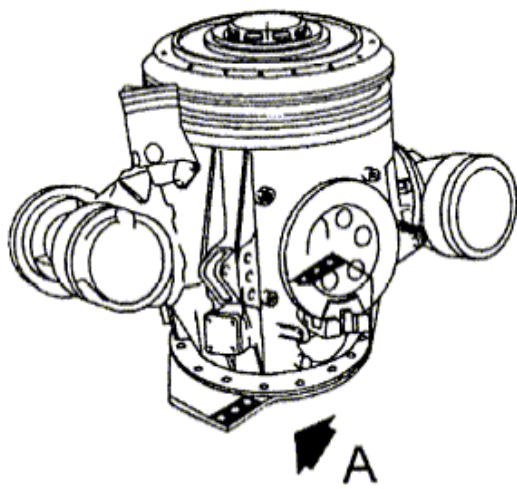
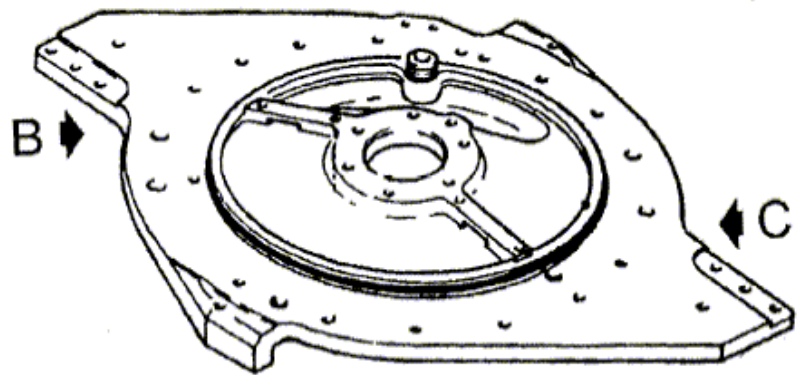
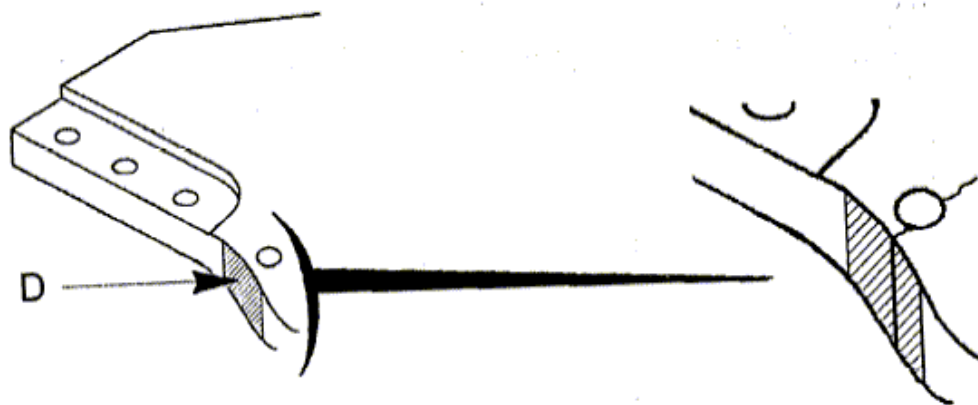
(a) Before the initial inspection at the time indicated in the compliance table, strip the paint from area "D" on both sides ("B" and "C") of the MGB base plate as depicted in Figure 1 of this AD.

(b) At the times indicated in the compliance table, inspect area "D" of the MGB base plate for a crack using a 10x or higher magnifying glass. Area "D" to be inspected is depicted in Figure 1 of this AD.

(c) If a crack is found in a MGB base plate, remove and replace the MGB with an airworthy MGB before further flight.
